INSTALLATION RESTORATION
PROGRAM
TECHNICAL MEMORANDUM FOR
FIELD INVESTIGATION AT
IRP SITES NO. 1 AND NO. 2

183rd FIGHTER WING
ILLINOIS AIR NATIONAL GUARD
CAPITAL MUNICIPAL AIRPORT
SPRINGFIELD, ILLINOIS

AUGUST 1997

Prepared For
ANG/CEVR
ANDREWS AFB, MARYLAND

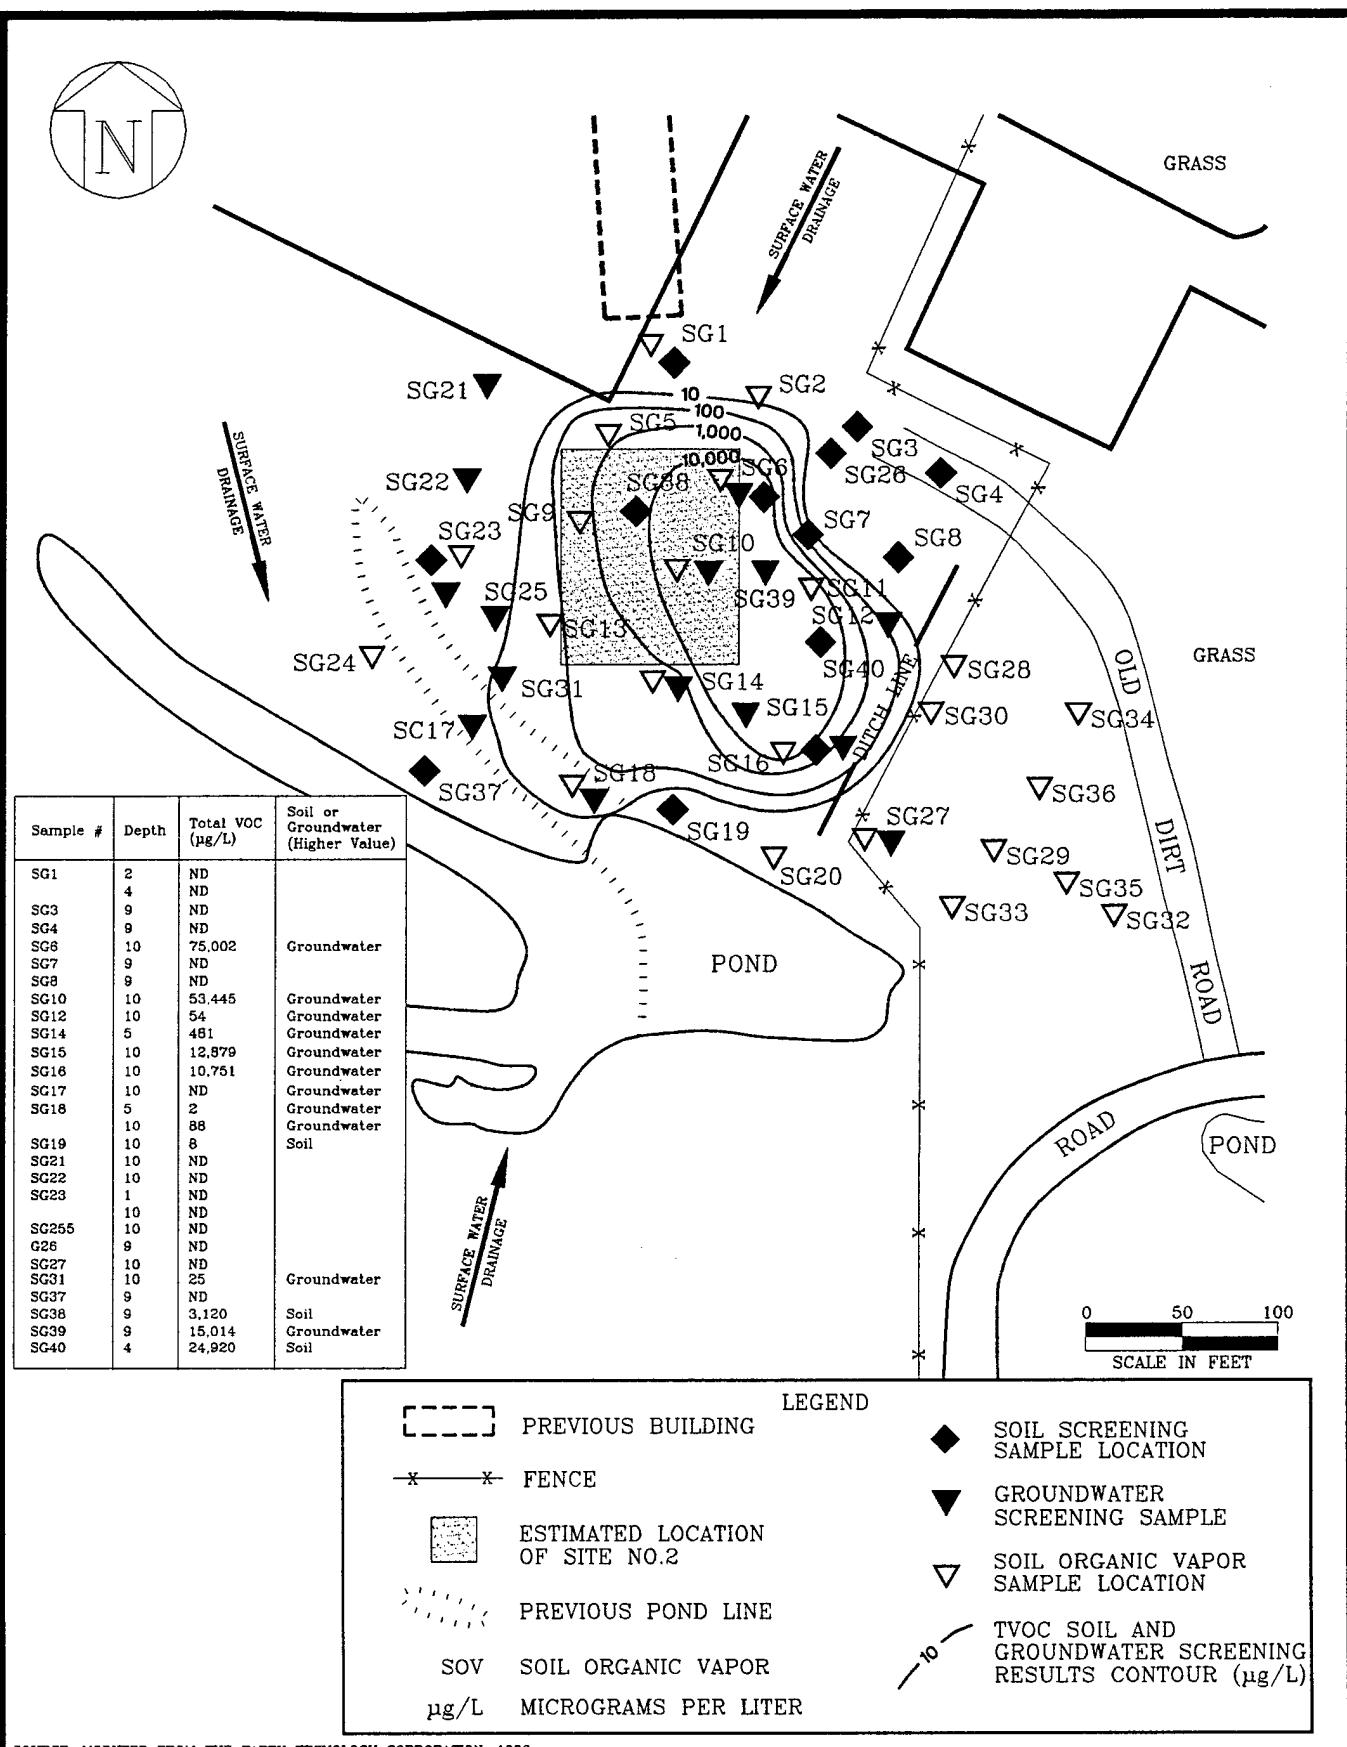
FIGURE 2.2

The results of the screening activities are presented in Figure 2.2. Seventeen surface- and subsurface-soil samples, six groundwater samples (two rounds of sampling from the monitoring wells), and three sediment and surface-water samples were collected for chemical analyses. These sampling locations are presented in Figure 2.3. The soil, groundwater, sediment, and surface-water samples were analyzed for VOCs, SVOCs, polychlorinated biphenyls (PCBs) and pesticides, and target analyte list (TAL) metals. The analytes that exceeded the ARARs or IEPA cleanup objectives are presented in Figure 2.3.

SITE NO.2 SI SOV, GRAB-TYPE
SOIL AND GROUNDWATER SCREENING
RESULTS - TOTAL VOCs
183rd FW, Illinois ANG
Springfield, Illinois

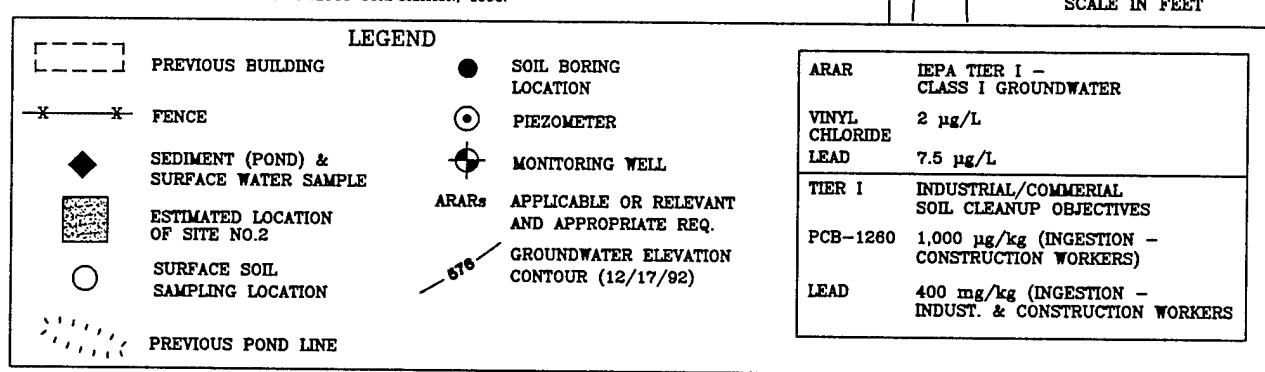
FIGURE 2.3

SI SAMPLING LOCATIONS
AND ANALYTES EXCEEDING ARARS
AT IRP SITE NO.2, OLD FTA
183rd FW, Illinois ANG
Springfield, Illinois

The results of the SI confirmed that soil and groundwater contamination, related to the past fire-training exercises, existed at the site. VOCs, SVOCs, pesticides/PCBs, and metals were found in the soil and sediment samples collected during the SI. Concentrations of VOCs and SVOCs did not exceed the IEPA cleanup objectives for soil on an industrial/commercial property. PCB-1260 was present in the surface- and subsurface-soil (4 - 6 foot interval) samples collected from location SB206 at concentrations exceeding the IEPA cleanup objective for ingestion to construction workers (Tier I).

The concentration of lead found in a surface-soil sample collected from location SB205 exceeded the IEPA cleanup objective for ingestion (Tier I). VOCs and metals were present in the groundwater samples collected during the SI. Vinyl chloride and lead were found in the groundwater sample collected from MW202 at concentrations exceeding the IEPA risk-based groundwater cleanup objectives for Class I groundwater (Tier I). Lead was also present in the groundwater sample collected from MW201 at a concentration exceeding the IEPA risk-based groundwater cleanup objective for Class I groundwater (Tier I).

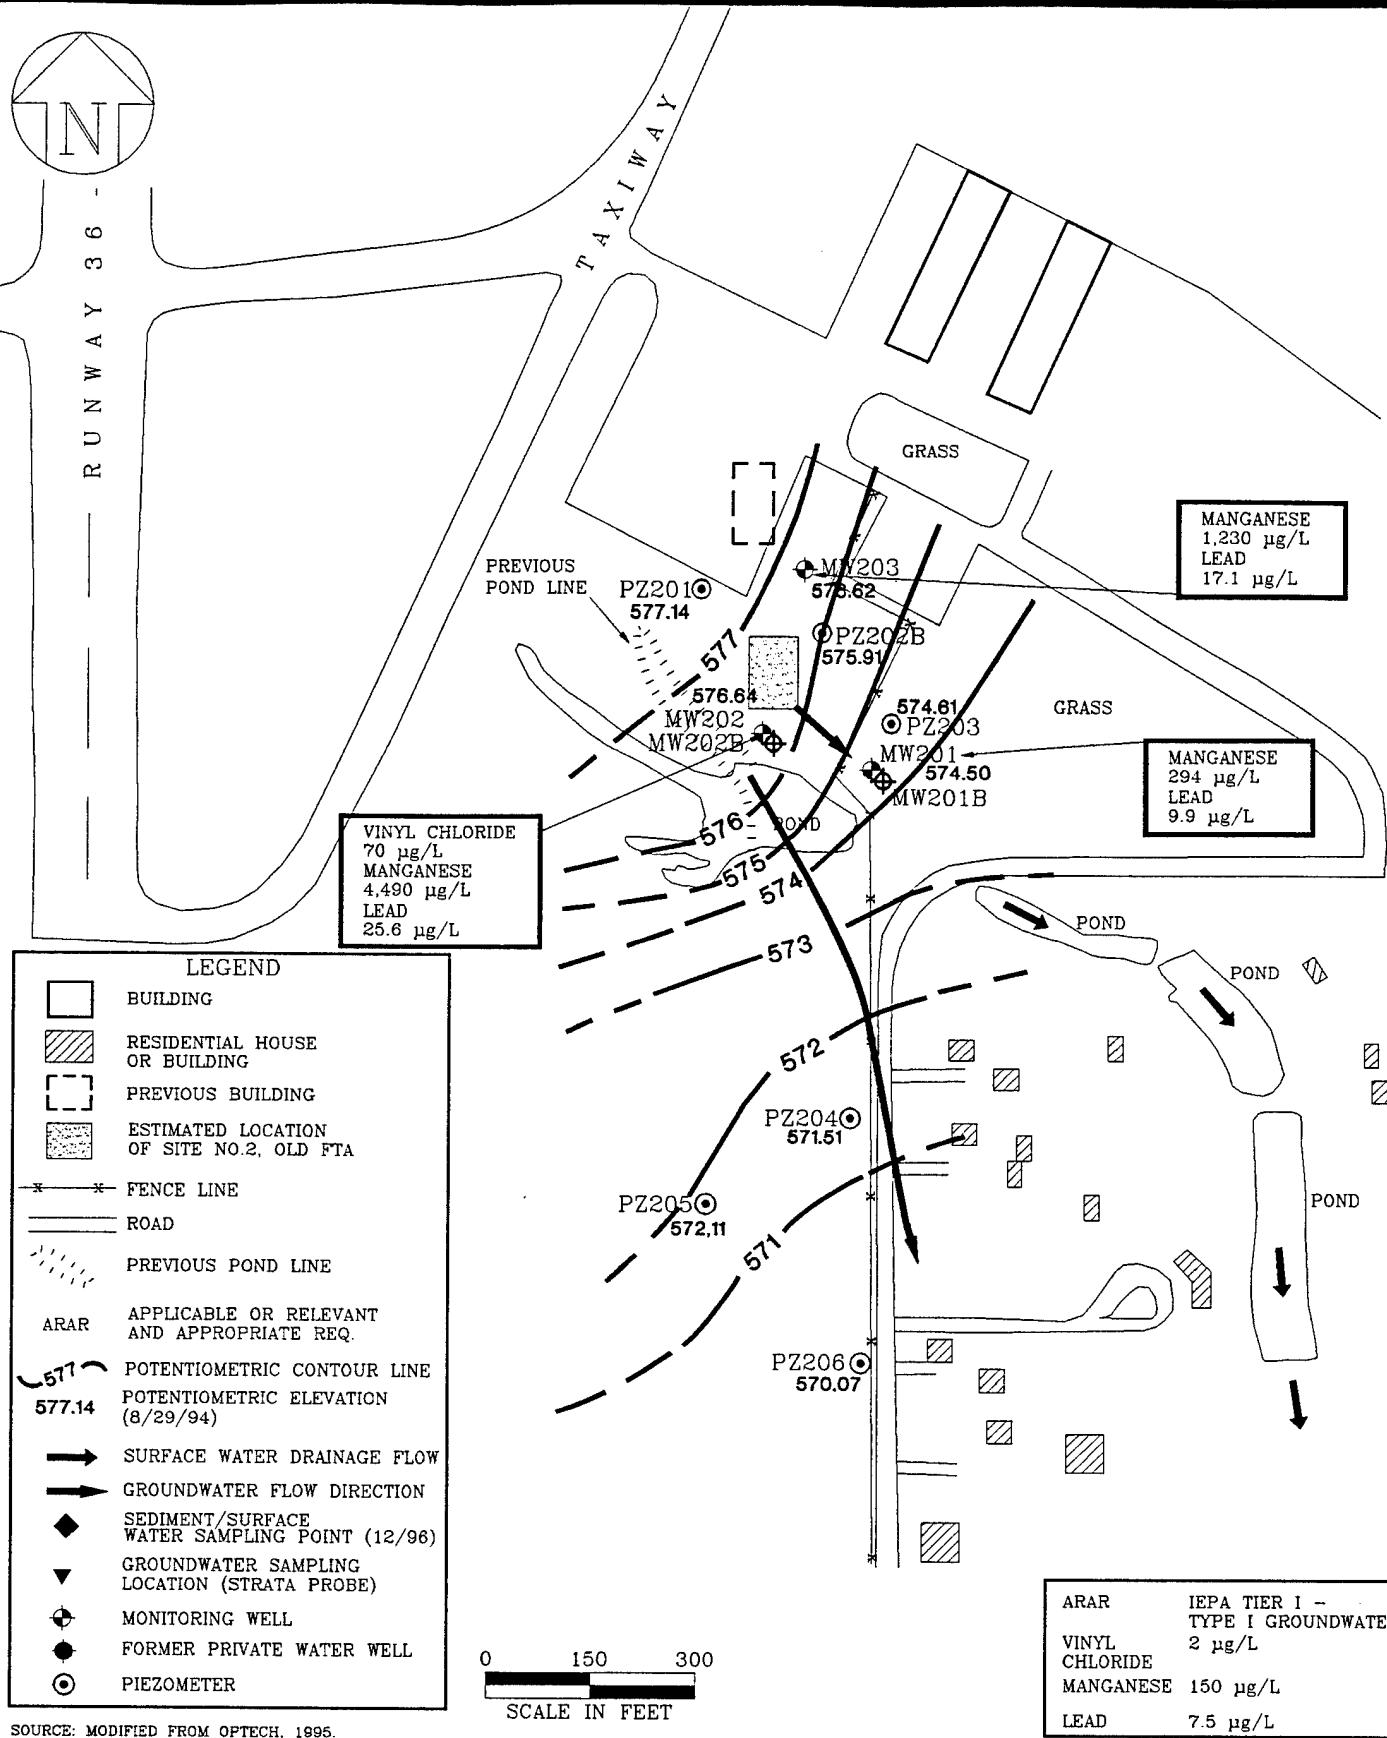
FIGURE 2.4

VOCs (U. S. Environmental Protection Agency (USEPA) modified Method SW846-8021) by an on-site laboratory. Groundwater samples that were collected from the existing monitoring wells were analyzed for the same analytes and by the same methods used for the SI. The analytes that exceeded the ARARs or IEPA cleanup objectives are presented in Figure 2.4.

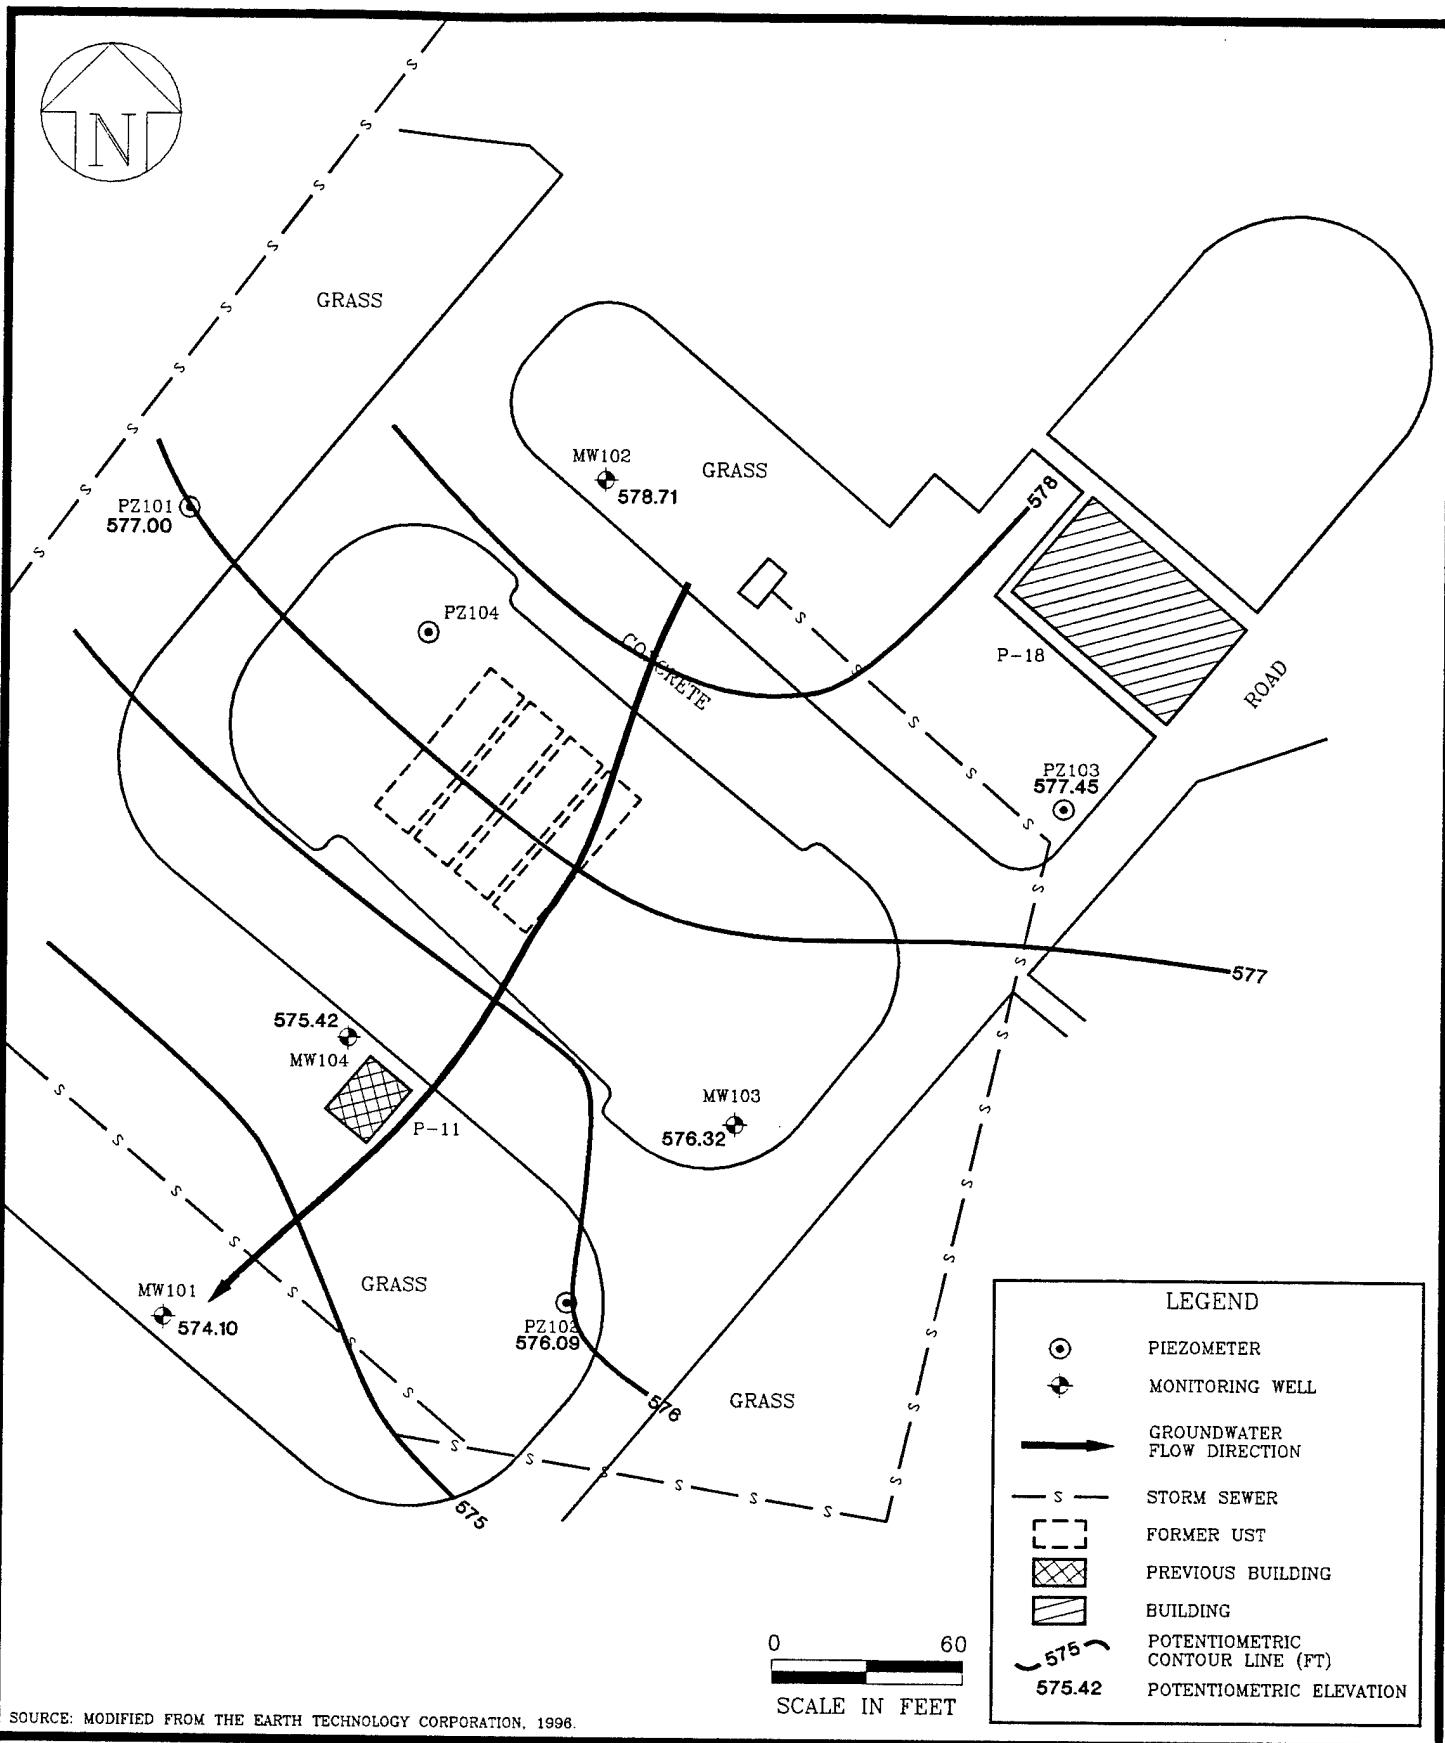
FIGURE 5.1

Potentiometric surface contour maps, constructed from water-level data collected on 18 December 1996 and 1 April 1997, are shown on Figures 5.1 and 5.2, respectively. The groundwater altitude data are presented in Table 5.1. The direction of groundwater movement is to the southwest with an average hydraulic gradient of 0.018 feet/foot (Figures 5.1 and 5.2).

POTENIOMETRIC SURFACE MAP,
18 DEC 1996, AT IRP SITE NO.1,
POL STORAGE AREA
183rd FW, Illinois ANG
Springfield, Illinois

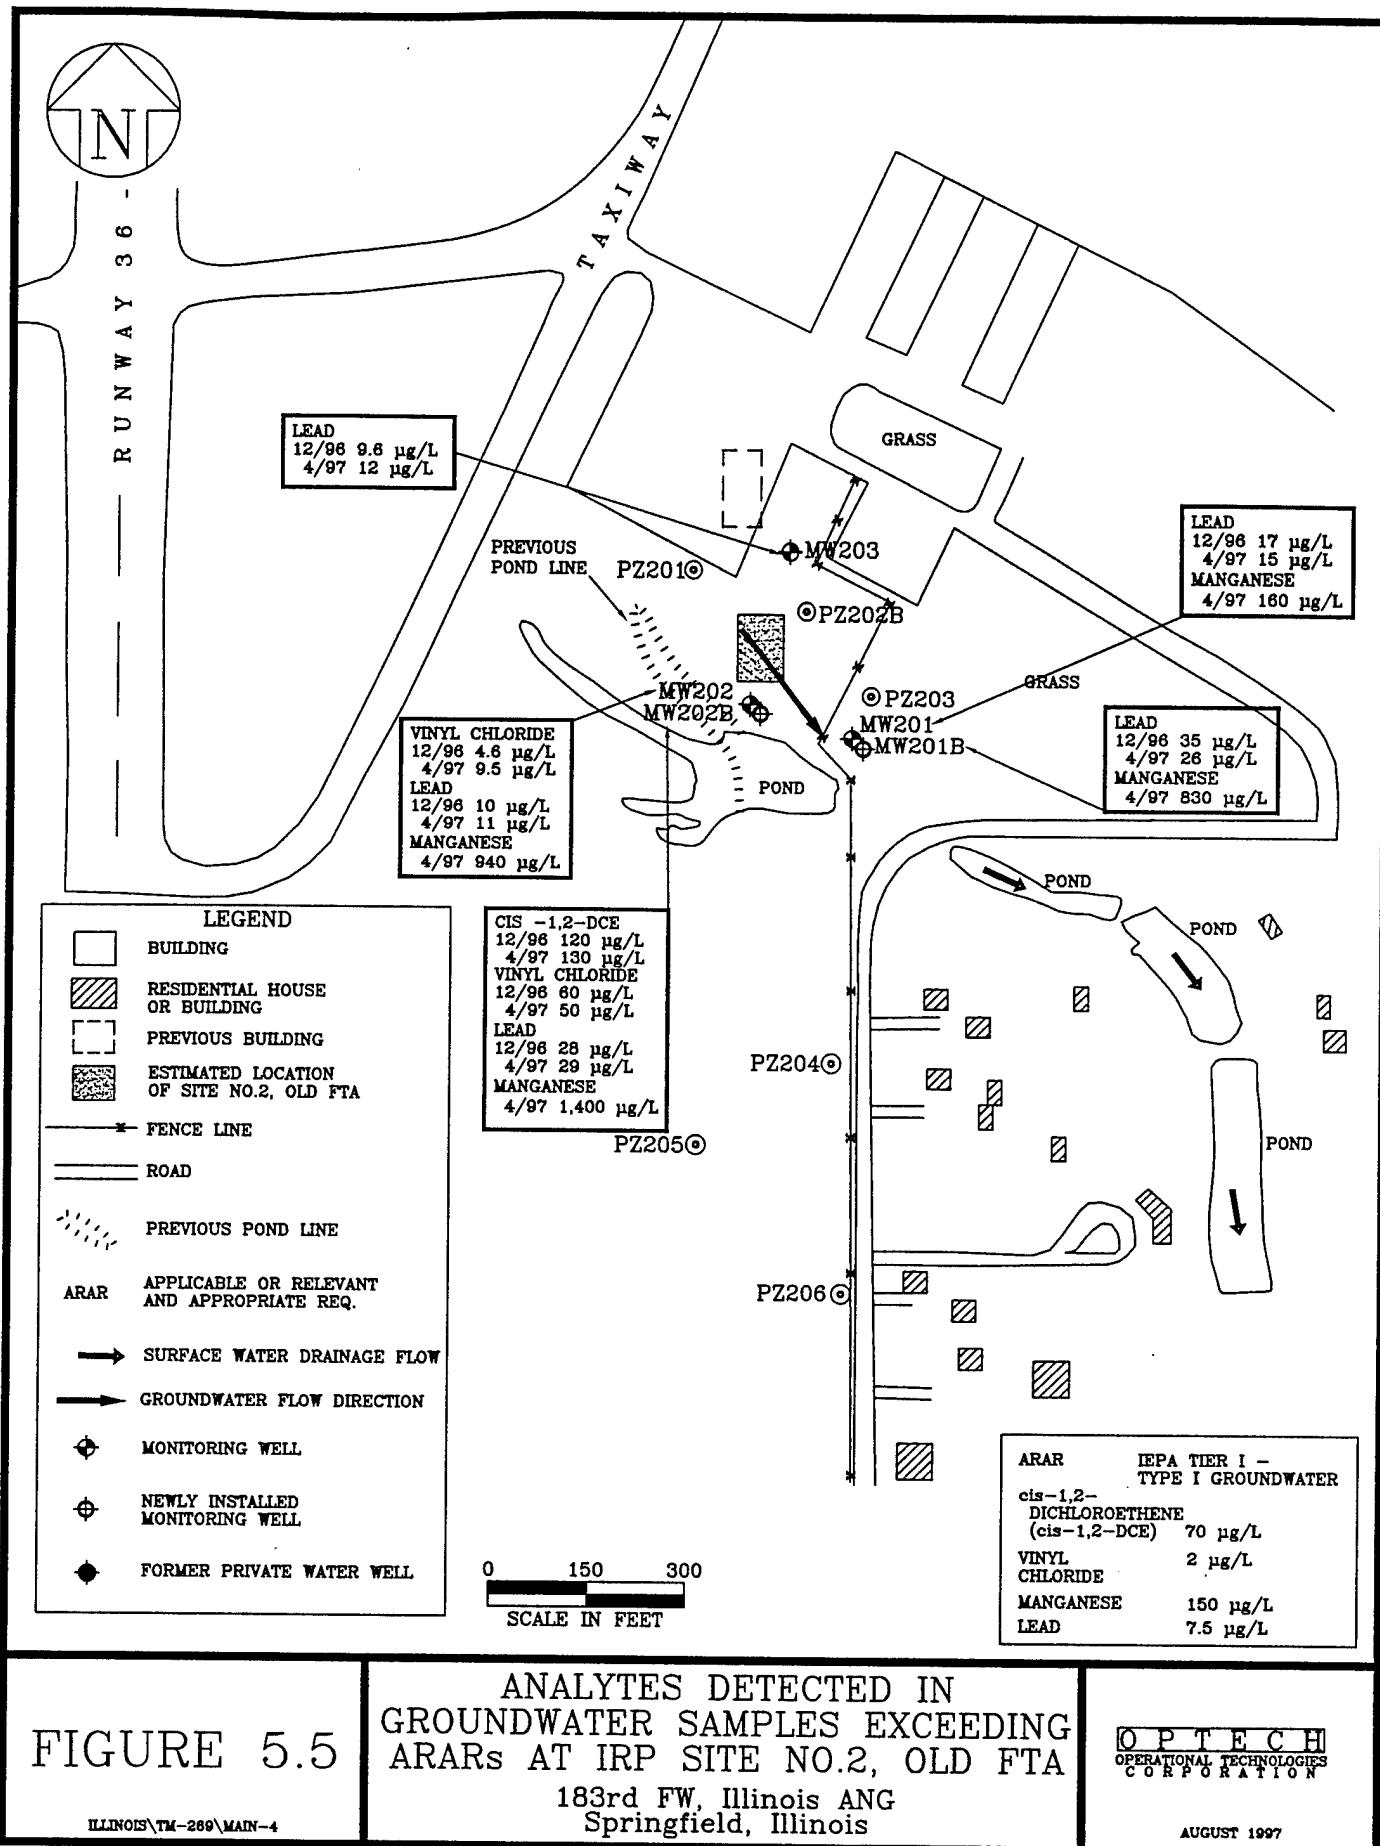
FIGURE 5.5

ANALYTES DETECTED IN
GROUNDWATER SAMPLES EXCEEDING
ARARs AT IRP SITE NO.2, OLD FTA

Vinyl chloride and cis-1,2-DCE were found at concentrations exceeding the IEPA ARARs in groundwater samples collected from the clustered monitoring wells (MW202 and MW202B) located directly downgradient from the FTA (Figure 5.5). Site-related compounds were not found exceeding IEPA ARARs in groundwater samples collected from the clustered monitoring wells (MW201 and MW201B) located approximately downgradient to cross-gradient from MW202. No site-related compounds were found in the surface-water and sediment samples collected from either the first or second ponds. The first and second ponds are located downgradient from monitoring wells MW202 and MW202B.

- Vinyl chloride and cis-1,2-DCE were found at concentrations exceeding the IEPA risk-based groundwater cleanup objectives for Class I groundwater in groundwater samples collected from the clustered monitoring wells (MW202 and MW202B) located directly downgradient from the FTA (Figure 5.5).
- No site-related compounds were found exceeding the IEPA risk-based groundwater cleanup objectives for Class I groundwater in groundwater samples collected from the clustered monitoring wells (MW201 and MW201B) located approximately downgradient from MW202.

- It is recommended that an Engineering Evaluation/Cost Analysis be conducted for the site. The resulting risk-based evaluation will determine the necessity for a removal action at IRP Site No. 2 based on environmental conditions.
